EVALUATION REPORT 12-59

A COMPARATIVE EVALUATION OF THE STANDARD U.S. NAVY
SHALLOW WATER DIVER'S MASK AND THE COMMERCIAL
P & E MANUFACTURING COMPANY'S MASK.

PROJECT NS 185-005 SUBTASK 2 TEST 13

12 FEBRUARY 1959

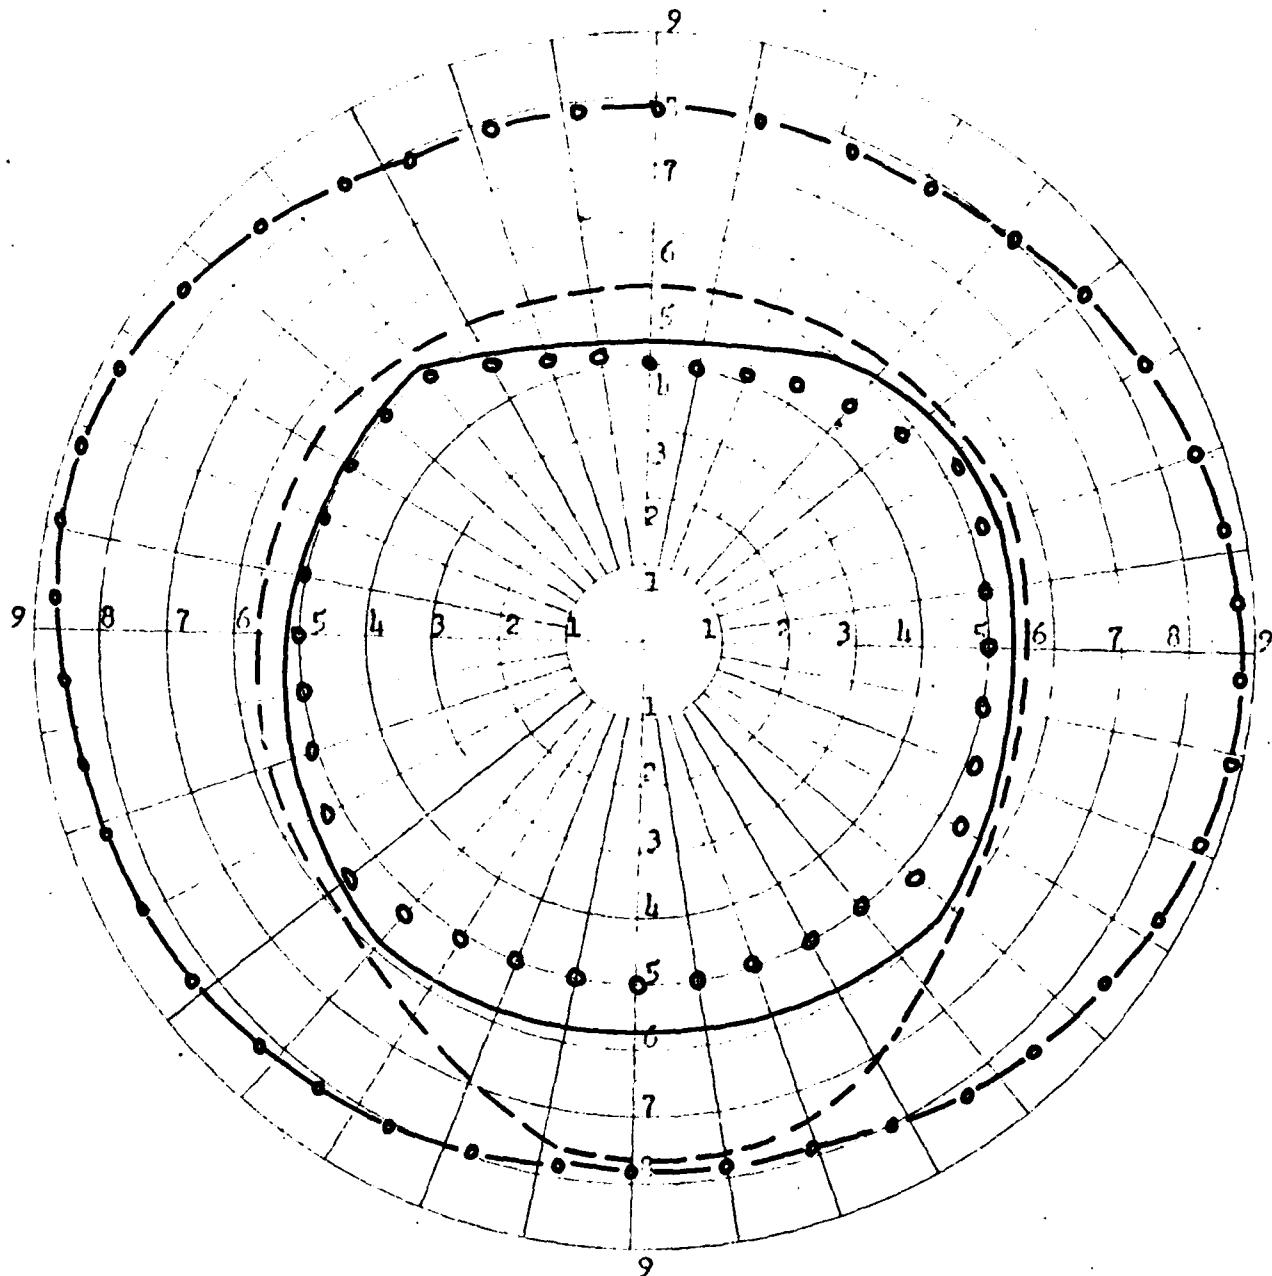
P&E MANUFACTURING CO INC.
SHALLOW WATER DIVERS MASK
VISUAL FIELD PERIMITERS
AVERAGE OF THREE SUBJECTS IN AIR AND WATER

4.4.1 Visual field perimeters as measured for the P & E Mask are plotted in figure 2. For purposes of comparison, the visual field perimeters for the Standard (Jack Brown) shallow water mask as previously reported in EDU Evaluation Report 4-57 are duplicated here as figure 3.

5.3.1 The visibility of the P & E mask is very good and, to a degree, better than the Standard mask. There has, however, never been any objection to the Standard mask's field of vision and, even during this evalution when specific comparison
